Screening Site Inspection Report

**Illinois Environmental
Protection Agency**
P.O. Box 19276
Springfield, IL 62794-9276

CARUS CHEMICAL CO.

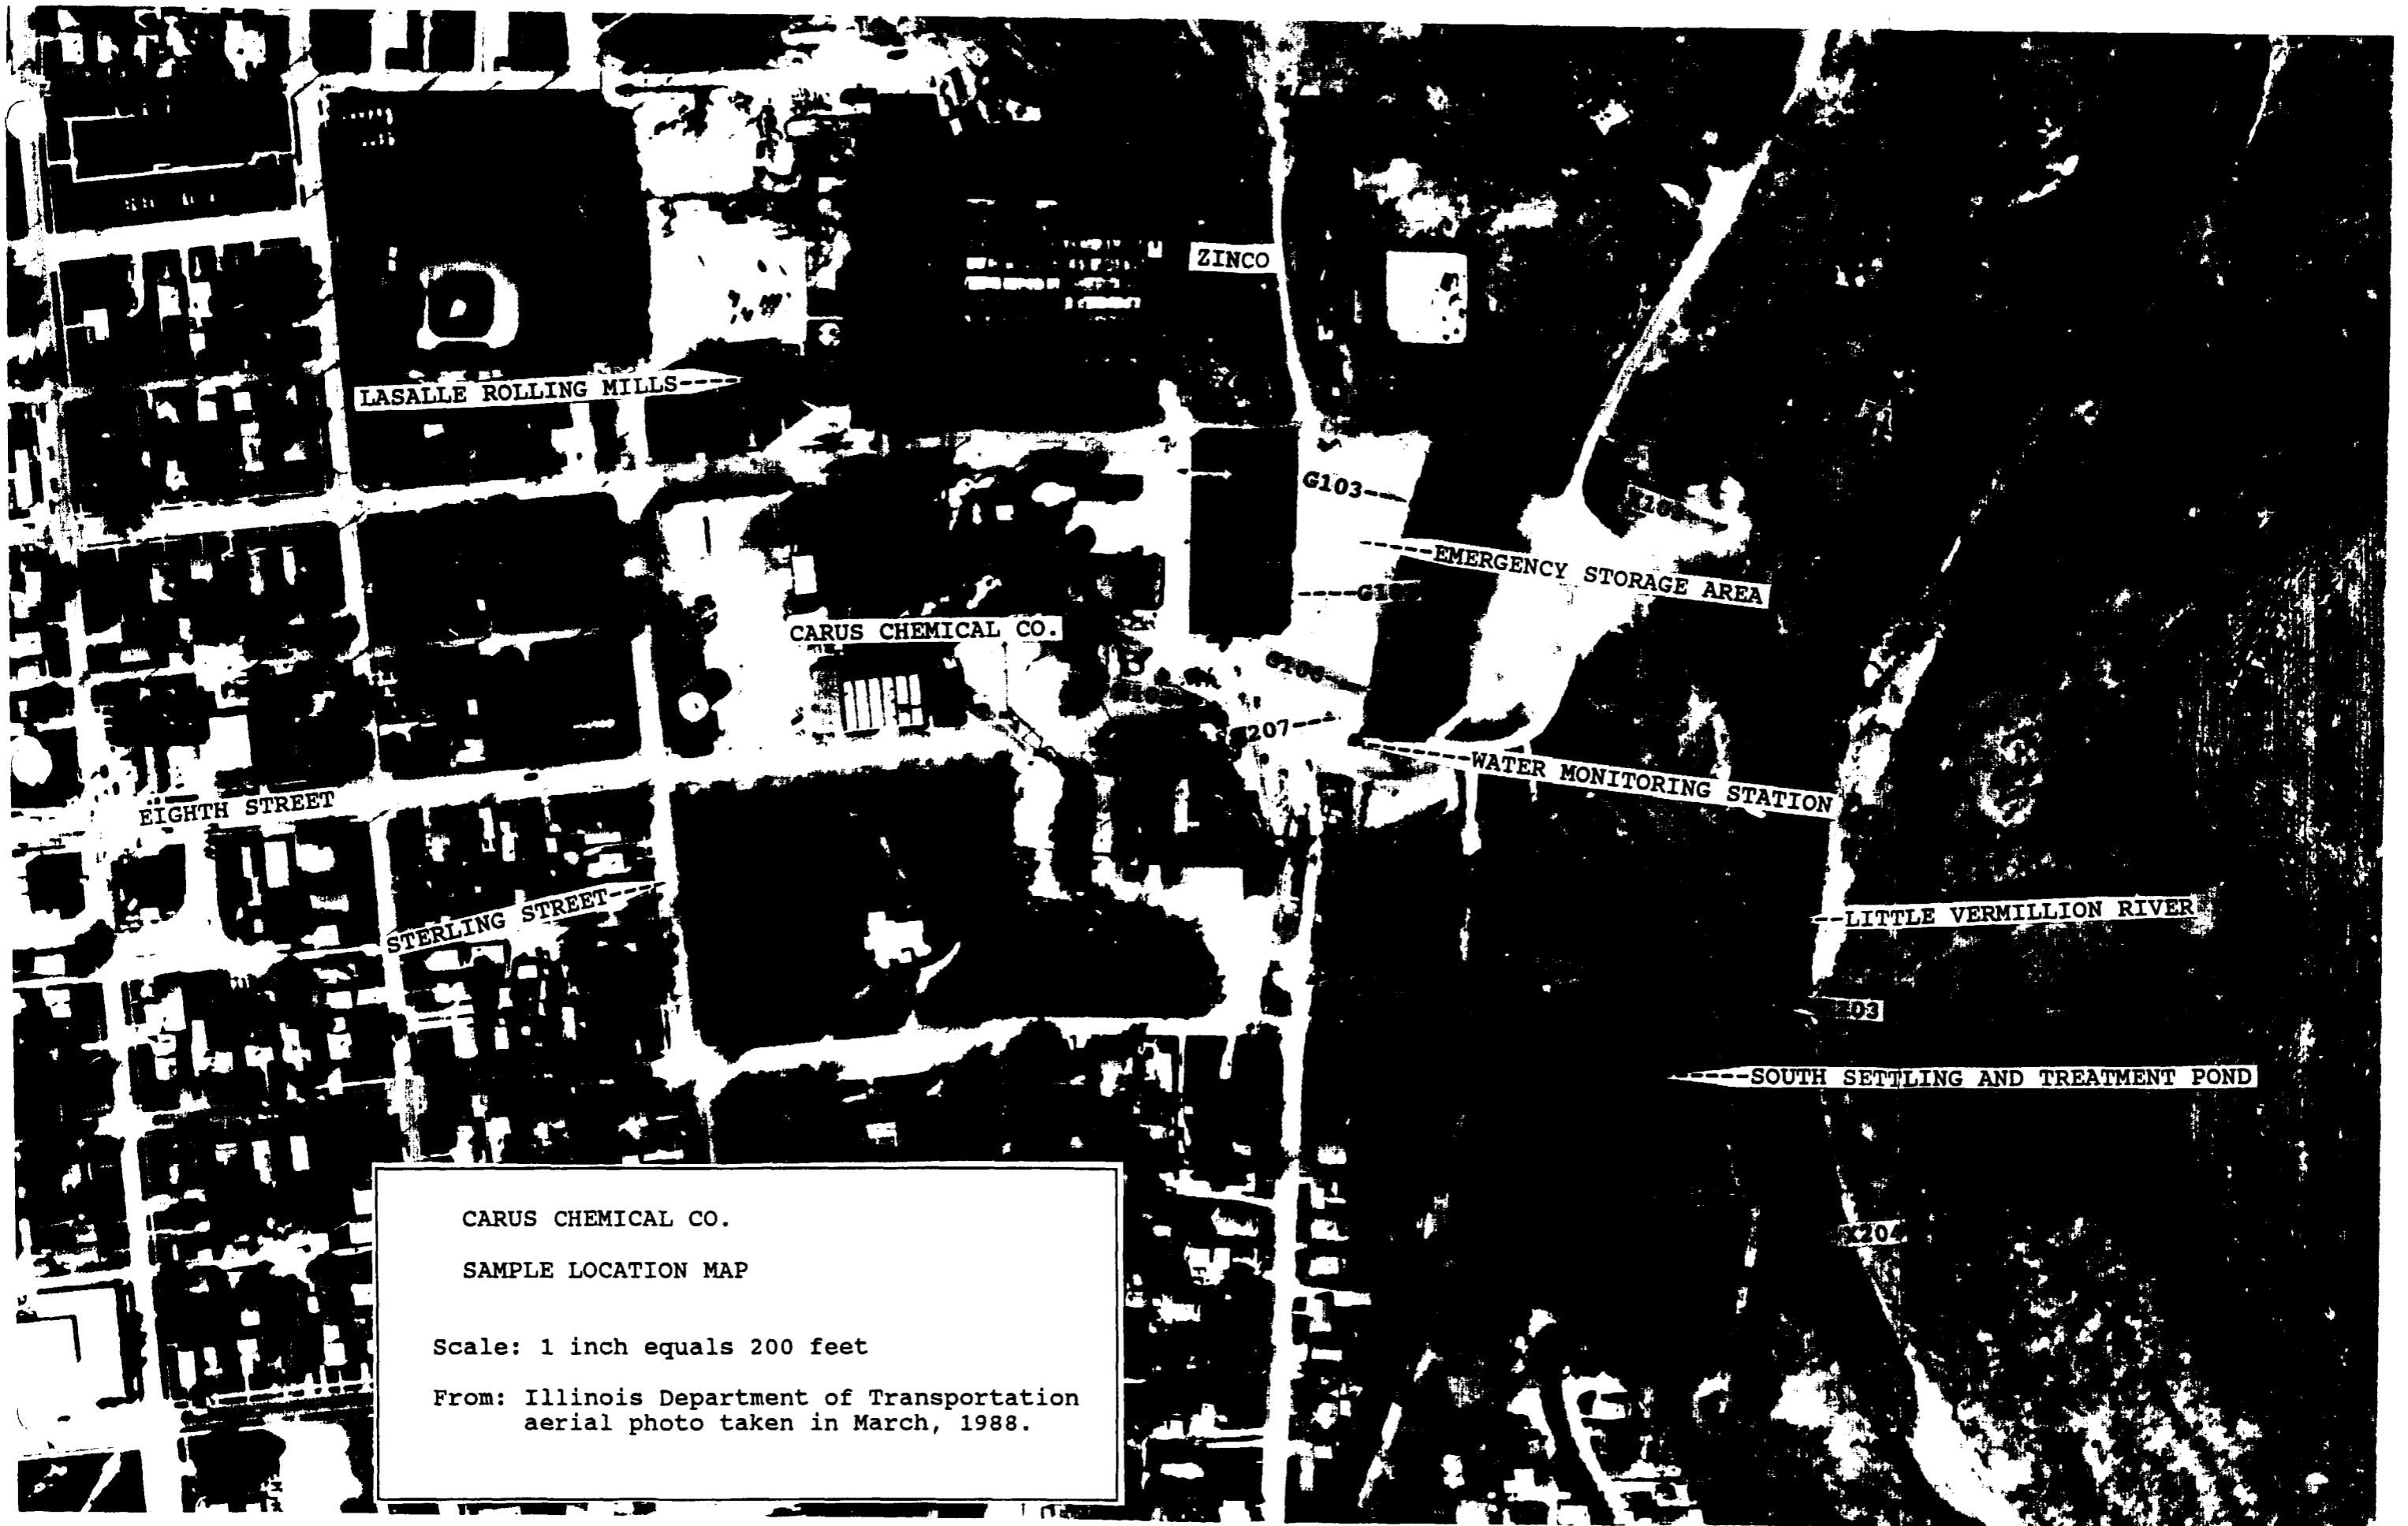
SAMPLE LOCATION MAP

From: Illinois Department of Transportation
aerial photo taken in March, 1988.

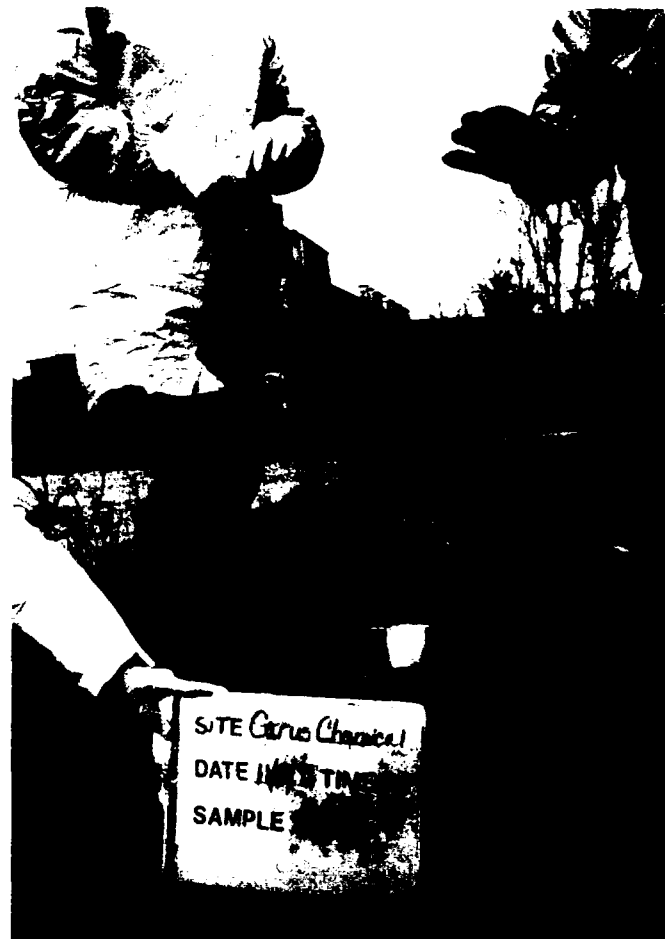
PICTURE TAKEN TOWARD
the southeast.

Sample point G106. Carus
monitoring well located
along the southeast edge
of Emergency Storage
Area.

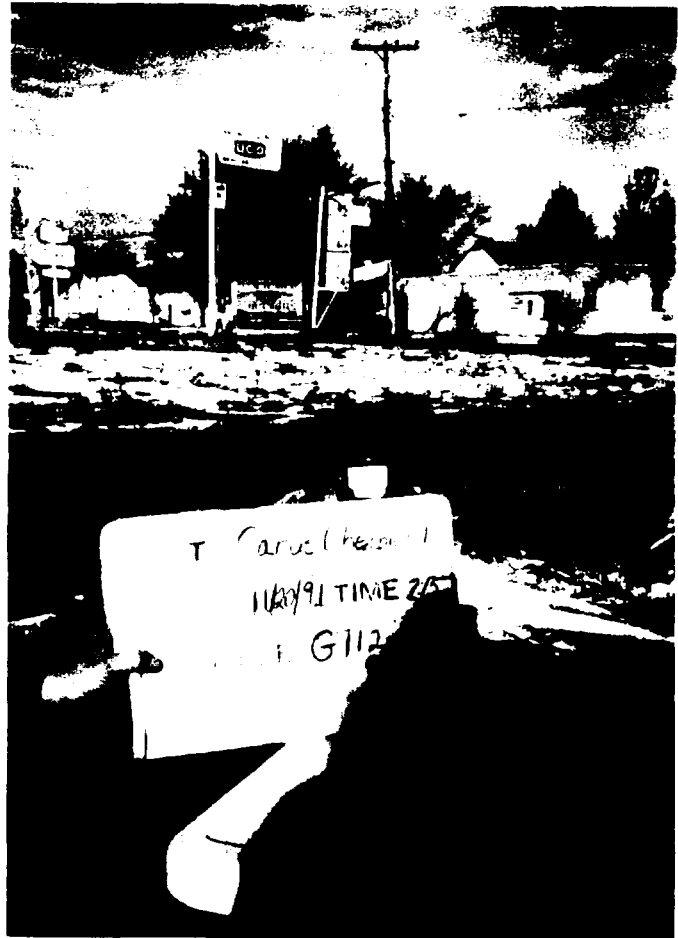
PICTURE TAKEN TOWARD
the south.

Sample point G112. Clear
plastic is used to
collect any water that
may be accidentally
spilled during sampling.

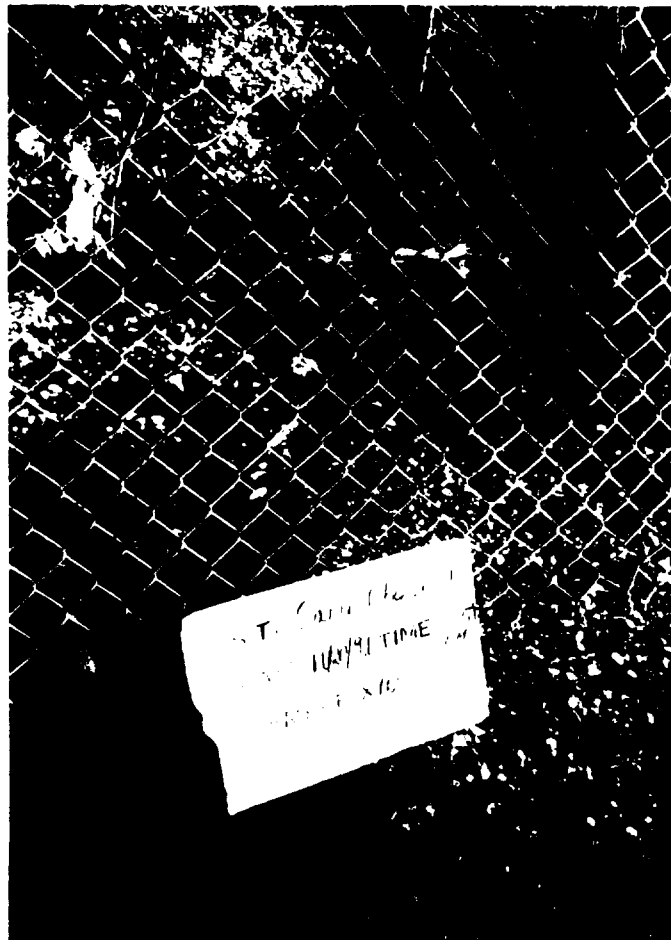
PICTURE TAKEN TOWARD
the north.

Sample X105. A portion of
the site drains toward
the southeast. The water
is diverted back to the
monitoring station before
it is allowed to enter
the south lagoon.

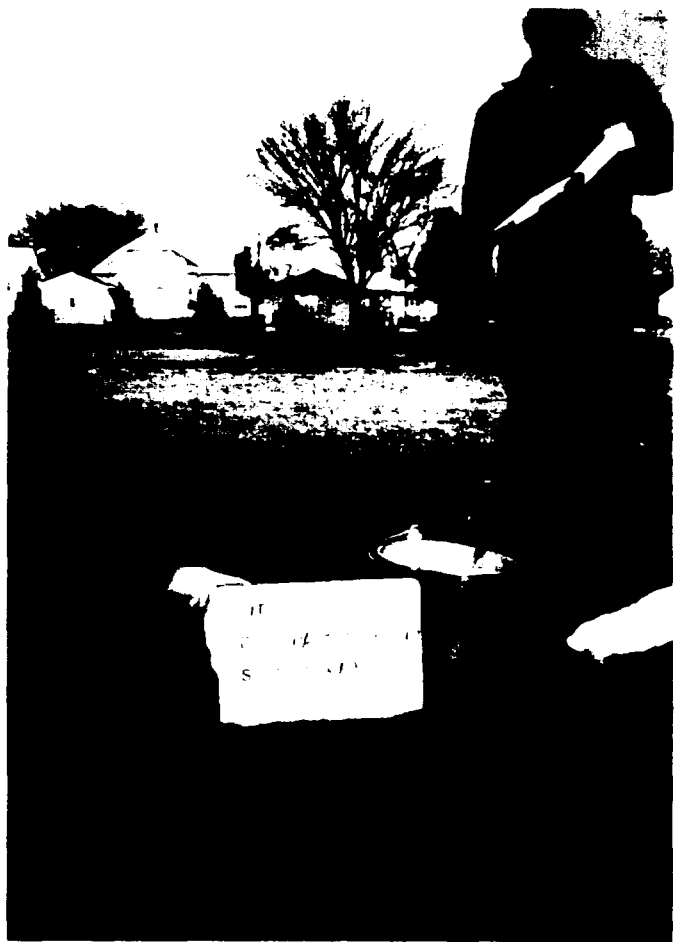
PICTURE TAKEN TOWARD
the south.

Sample point X101
collected from Hageler
Park. Swimming pools are
in the background.

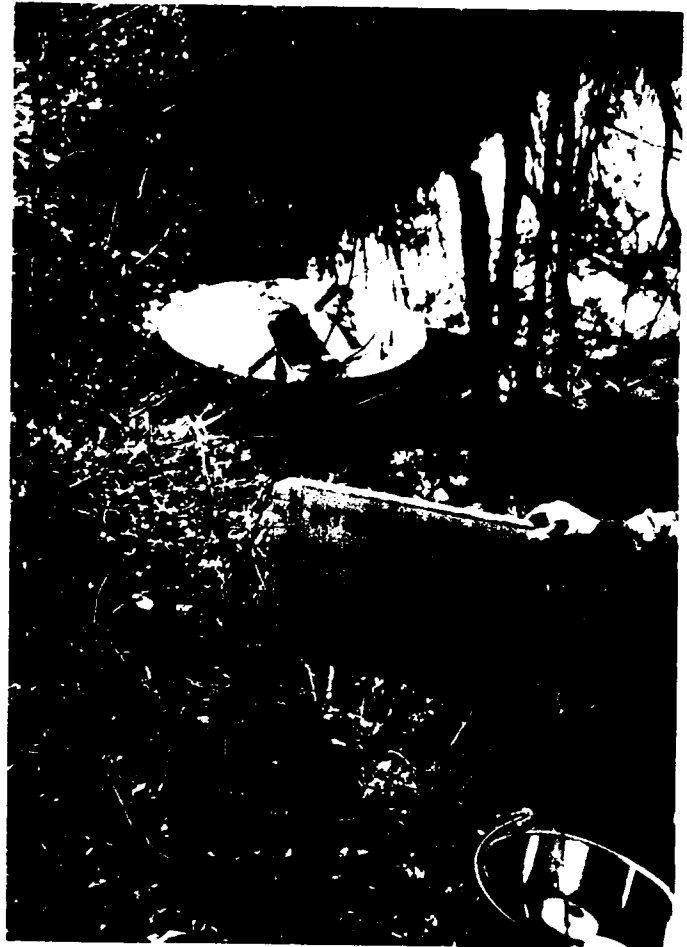
PICTURE TAKEN TOWARD
the north.

Sample point X205.
South Lagoon is on the
left. Fog in the back-
ground is caused by the
water entering the pond
being warmer than the
surrounding air.

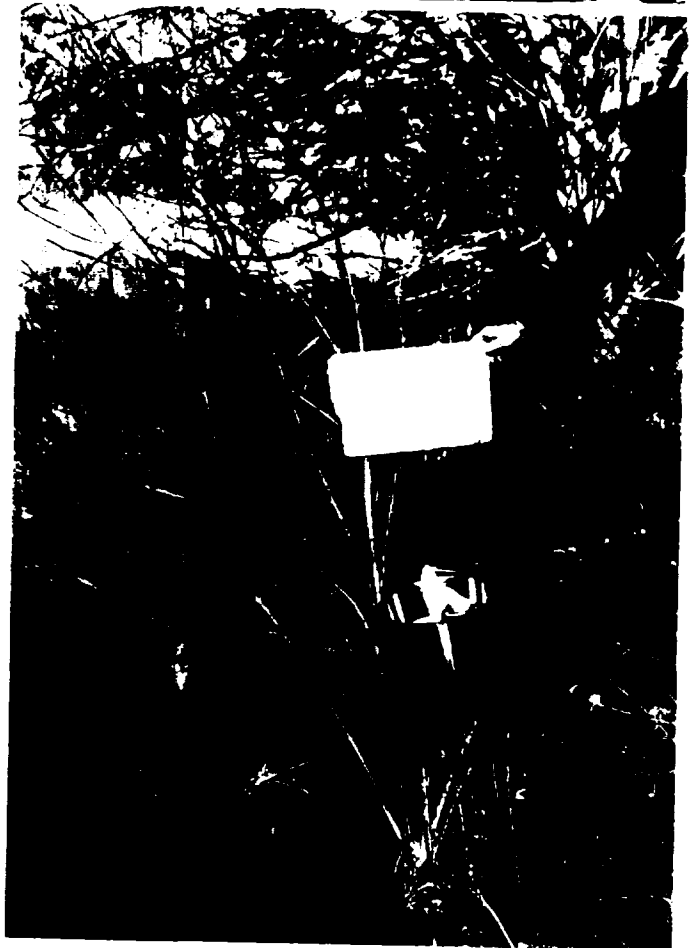
PICTURE TAKEN TOWARD
the east.

Sample point X206.
Sediment sample obtained
from a delta formed
where the water from the
plant enters the South
Lagoon. Collected at a
depth of 0 to 8 inches.

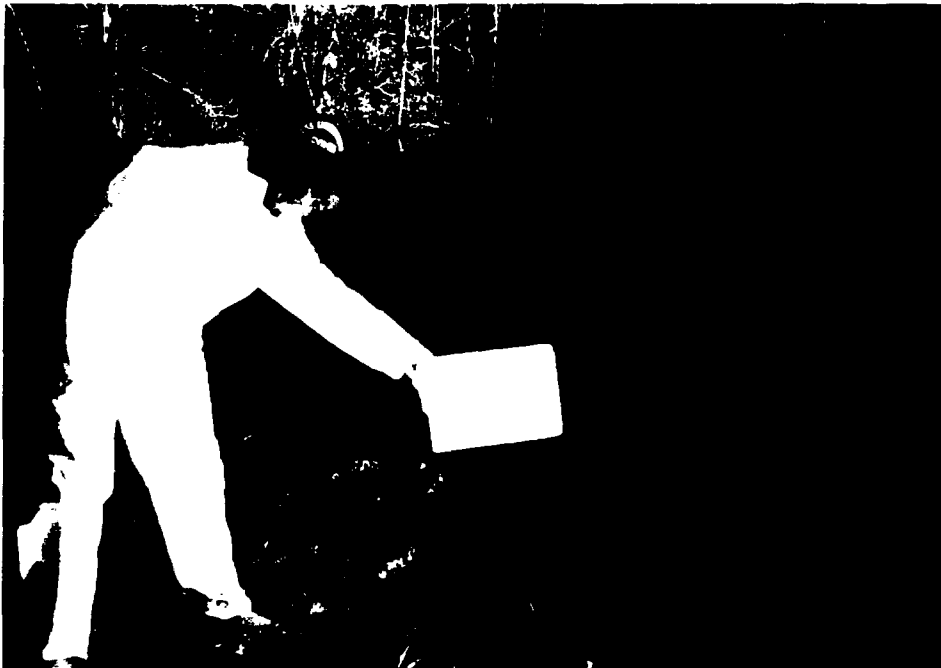
PICTURE TAKEN TOWARD
the south.

Sample point X206. Photo
taken away from sampling
point and shows portion
of the delta, which
extends back to the pipe
that passes through the
monitoring station.

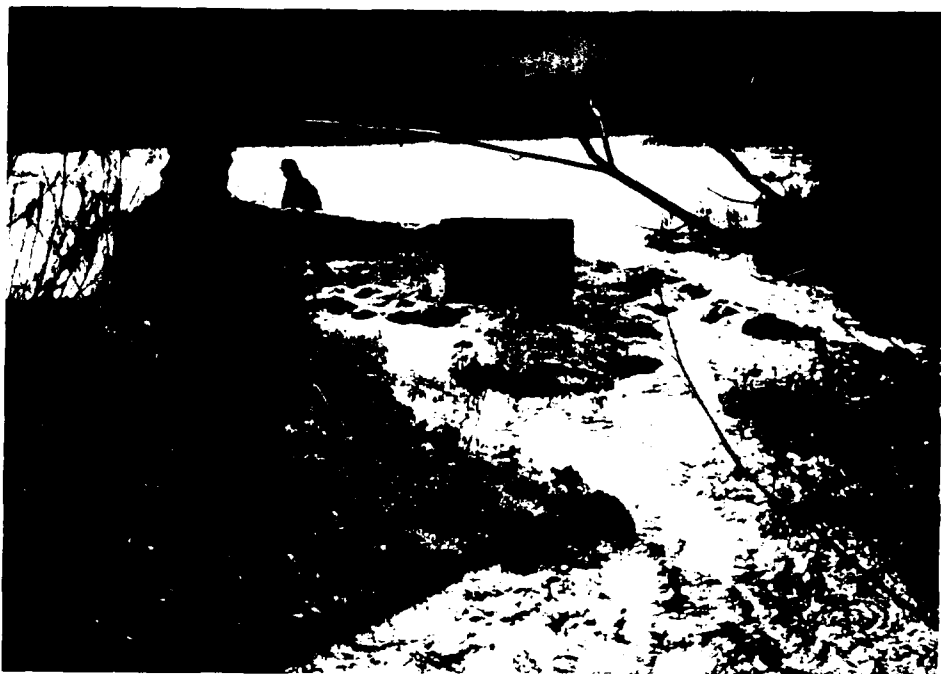
PICTURE TAKEN TOWARD
the south.

Sample point X203.
Sediment sample from the
Little Vermilion River
at a point located down-
stream from runoff
ditches and an outfall
pipe. Collected at a
depth of 0 to 8 inches.

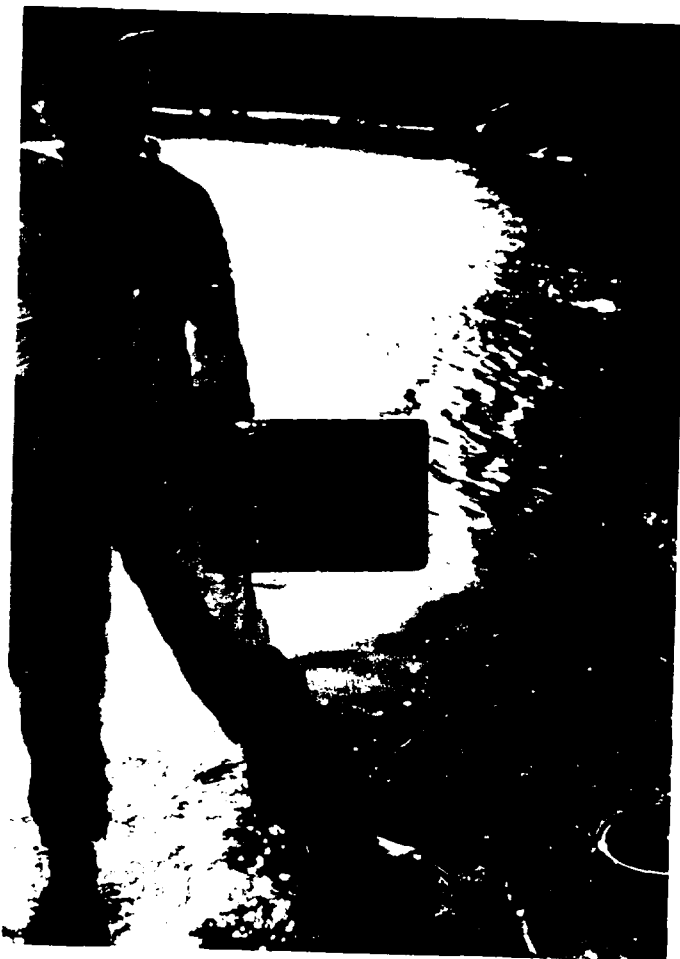
PICTURE TAKEN TOWARD
the north.

Sample point X203 on the
west bank of the Little
Vermilion River. Land at
the upper left corner
risers sharply.

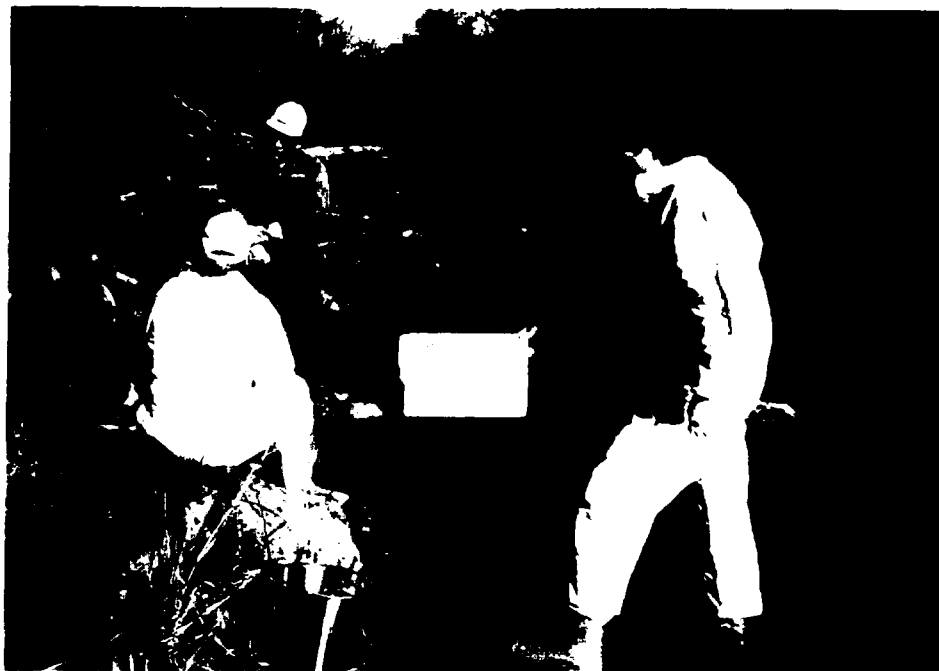
PICTURE TAKEN TOWARD
the north.

Sample point X103. This
soil sample was inadvert-
ently labeled as sample
X203 on the photo board.
Collected at a depth of 0
to 6 inches.

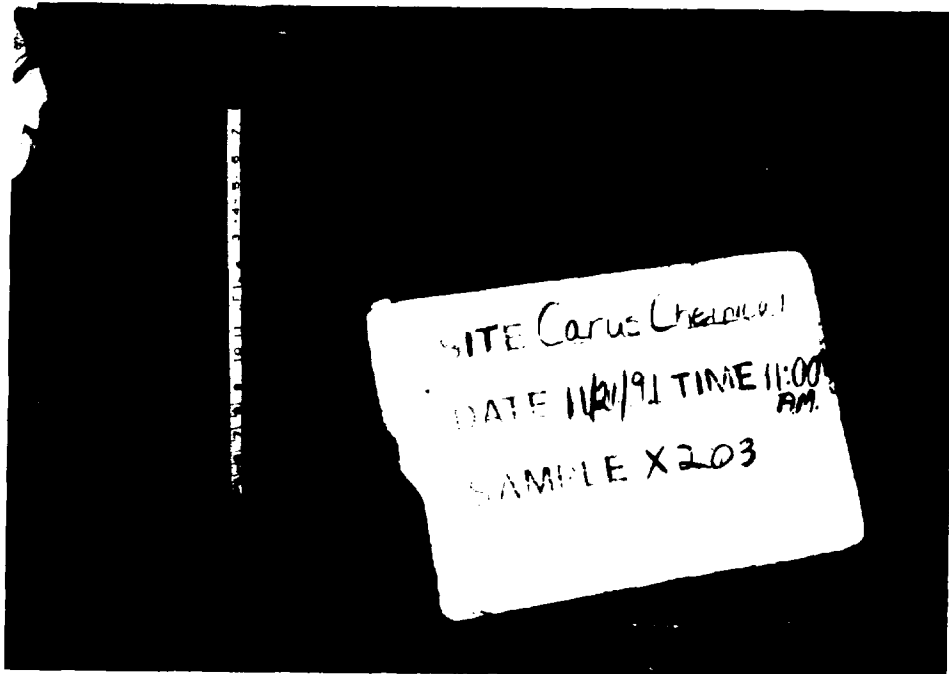
PICTURE TAKEN TOWARD
the south.

Sample point X103. This
soil sample was inadvert-
ently labeled as X203.
The sample was collected
in an area where slag was
deposited from the zinc
processing facility
located to the north.

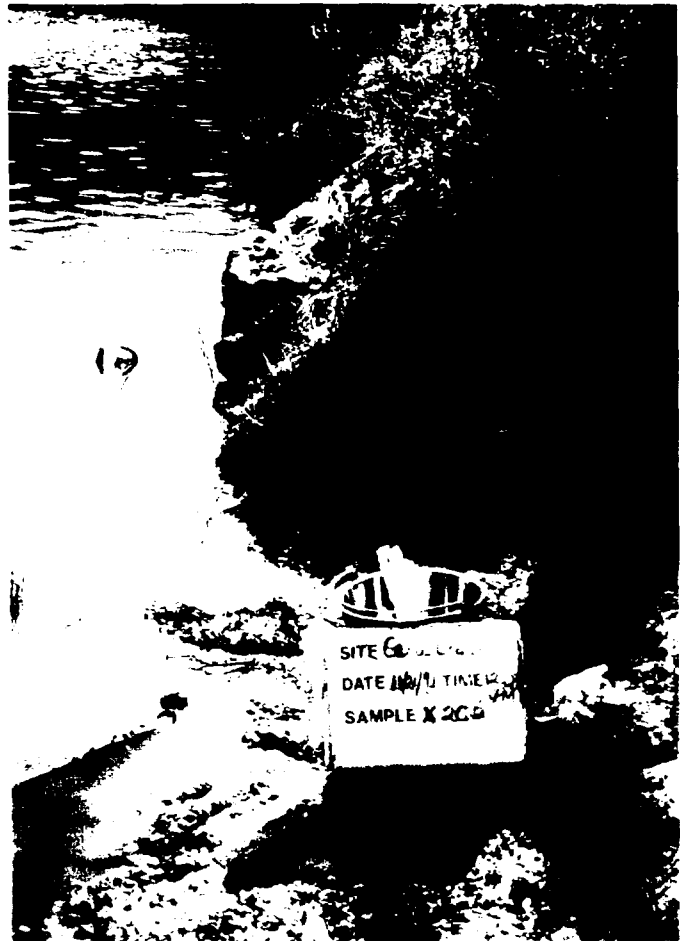
PICTURE TAKEN TOWARD
the north.

Sample X202. Sewer
outfall is located to the
upper left.
